NONDESTRUCTIVE TESTING OF DIFFUSION BONDED TITANIUM  
ALLOYS FOR ENGINE AND AIRFRAME COMPONENTS

**AFML-TR-74-215**

*FORT WORTH DIVISION  
GENERAL DYNAMICS CORPORATION*

**AIR FORCE MATERIALS LABORATORY  
AIR FORCE SYSTEMS COMMAND  
WRIGHT-PATTERSON AIR FORCE BASE, OHIO 45433**

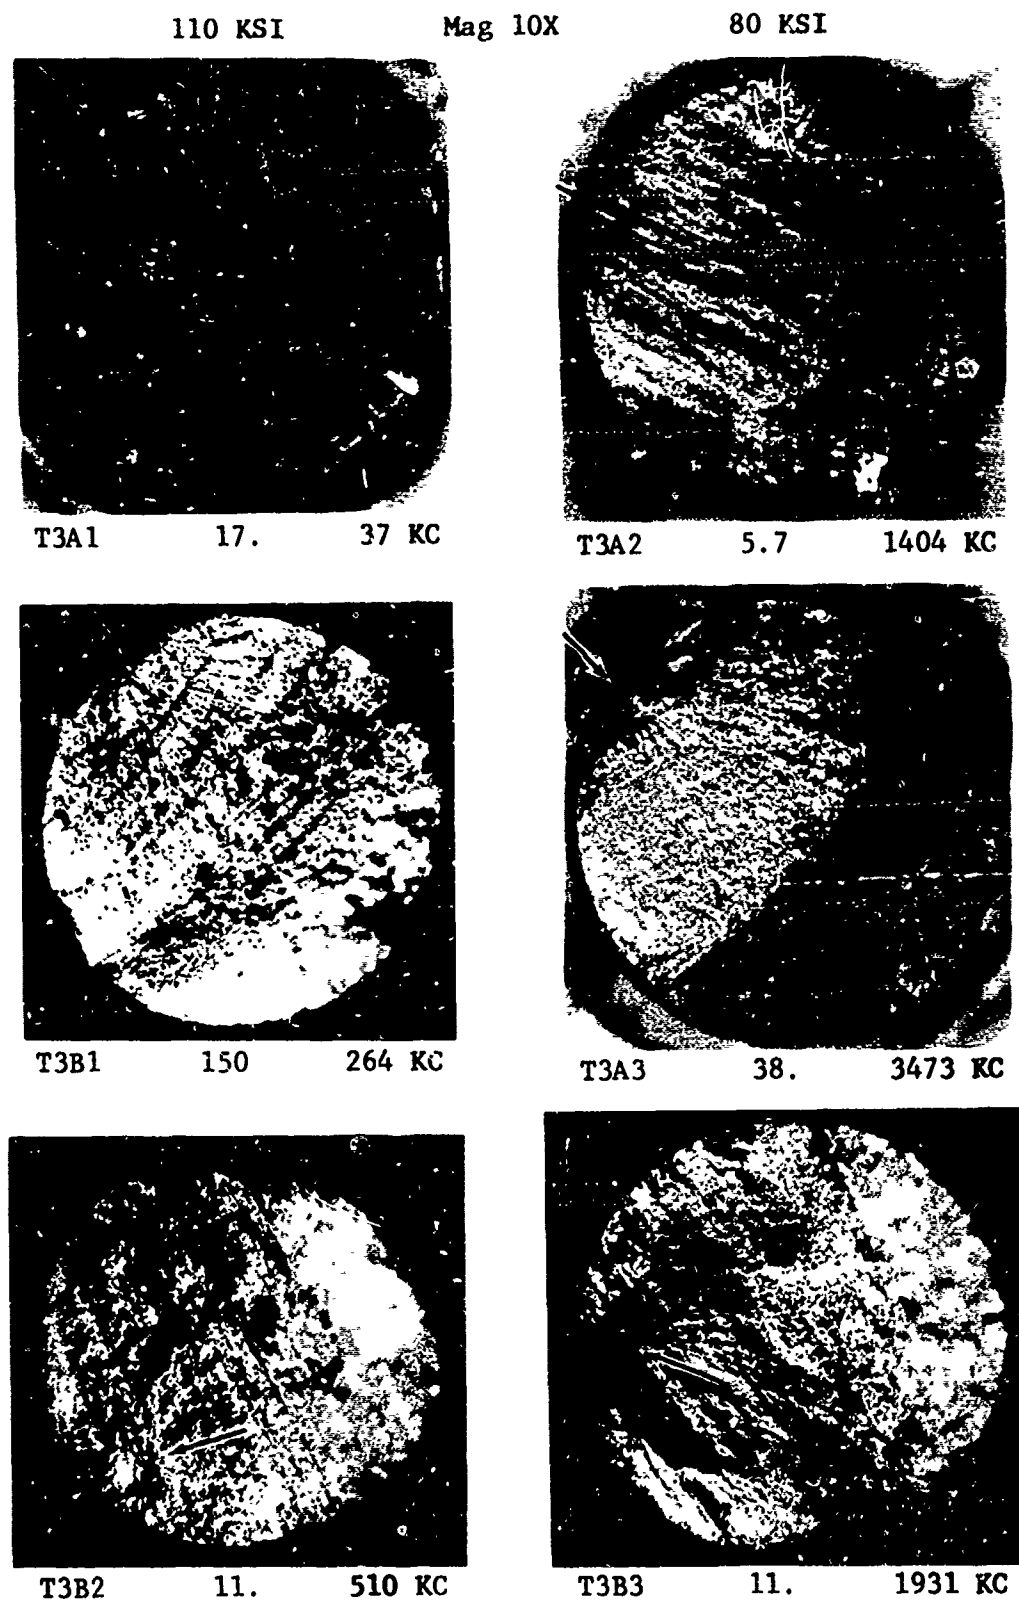
Figure 8.30 Fracture Surfaces of Failed Fatigue Specimens Series T3-  
Single Joint Diffusion Bonded with .01" Dia. Surface Void

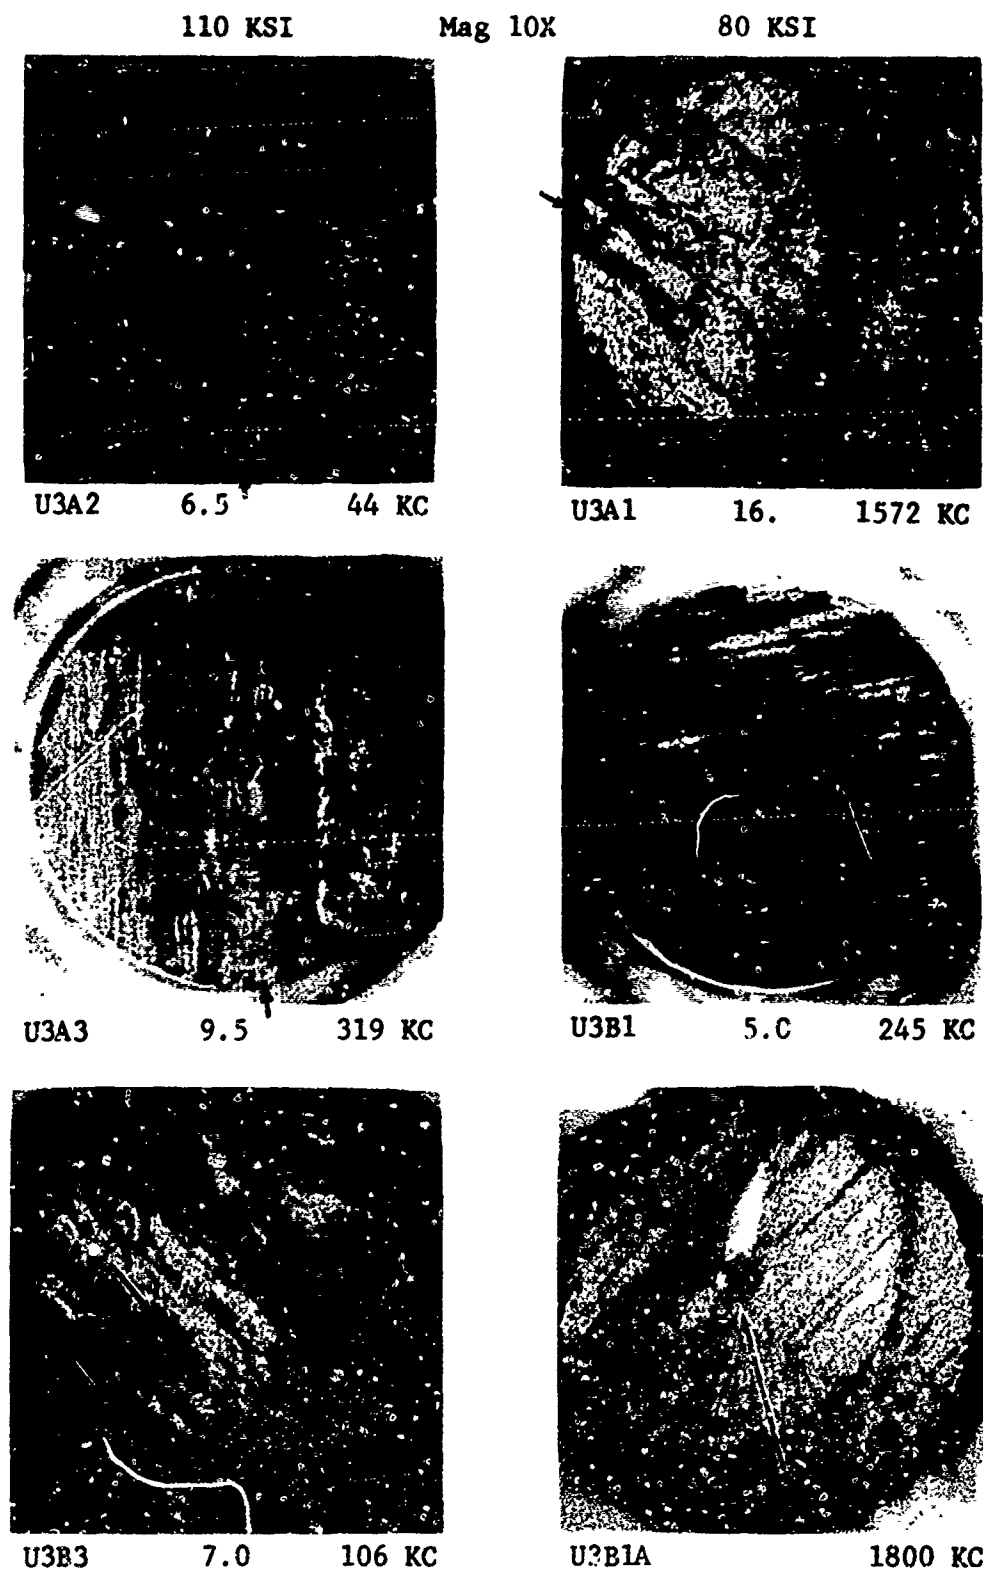
Figure 8.31 Fracture Surfaces of Failed Fatigue Specimens Series U3-  
Single Joint Diffusion Bonded with .02" Dia. Surface Void

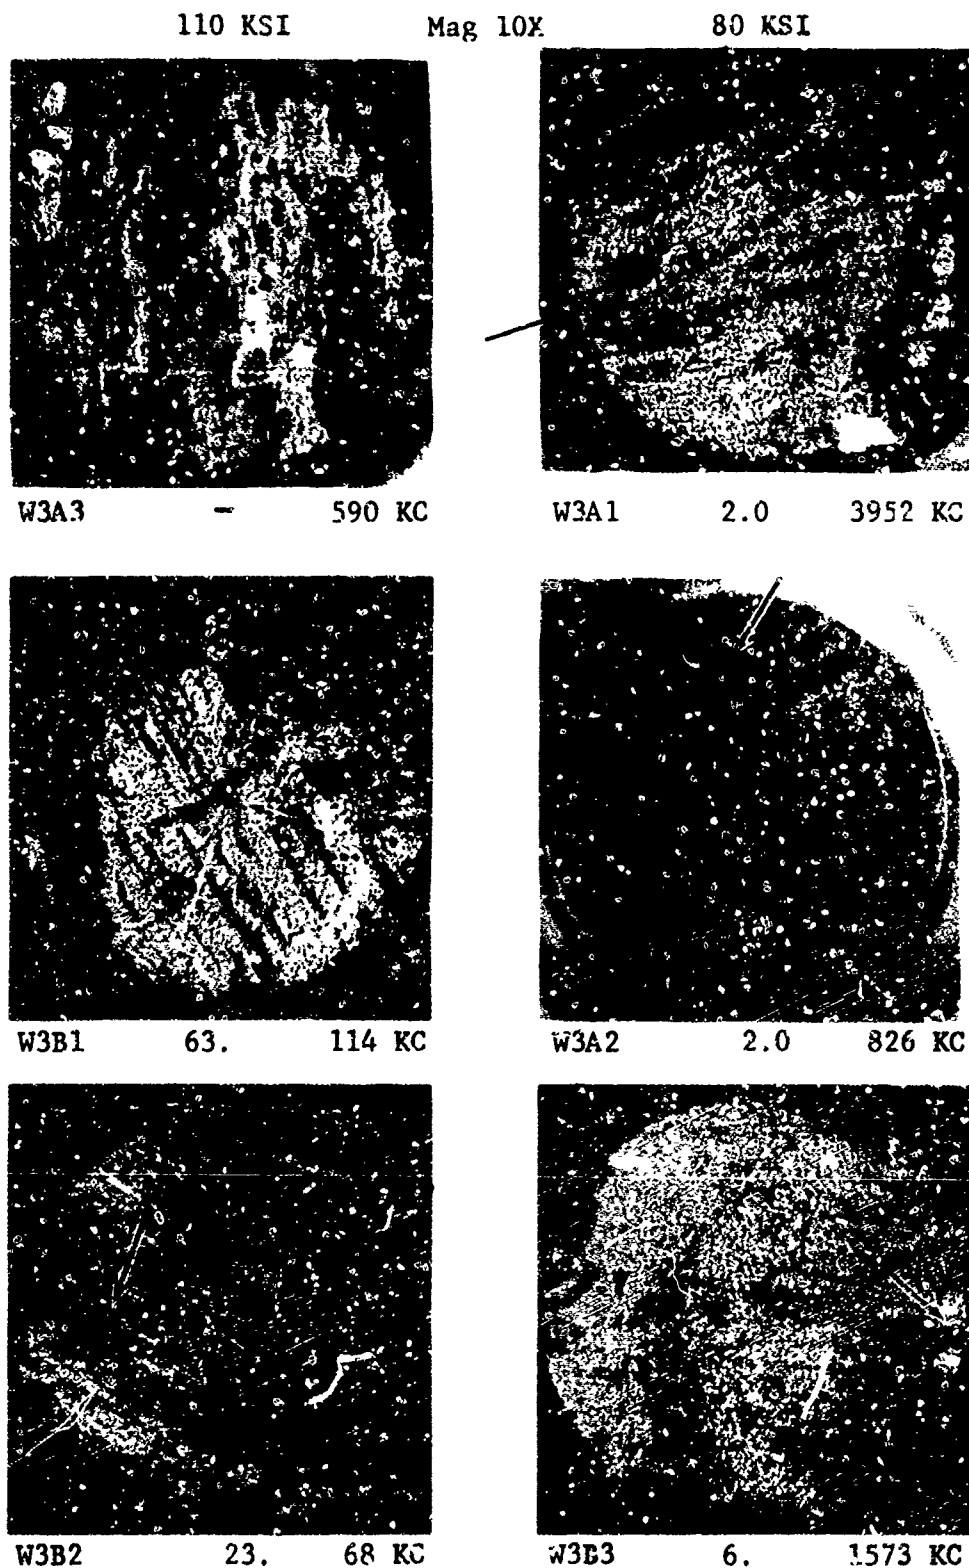
Figure 8.33 Fracture Surfaces of Failed Fatigue Specimens Series W3-  
Single Joint Diffusion Bonded with .013" Dia. Stainless  
Steel Powder Inclusion

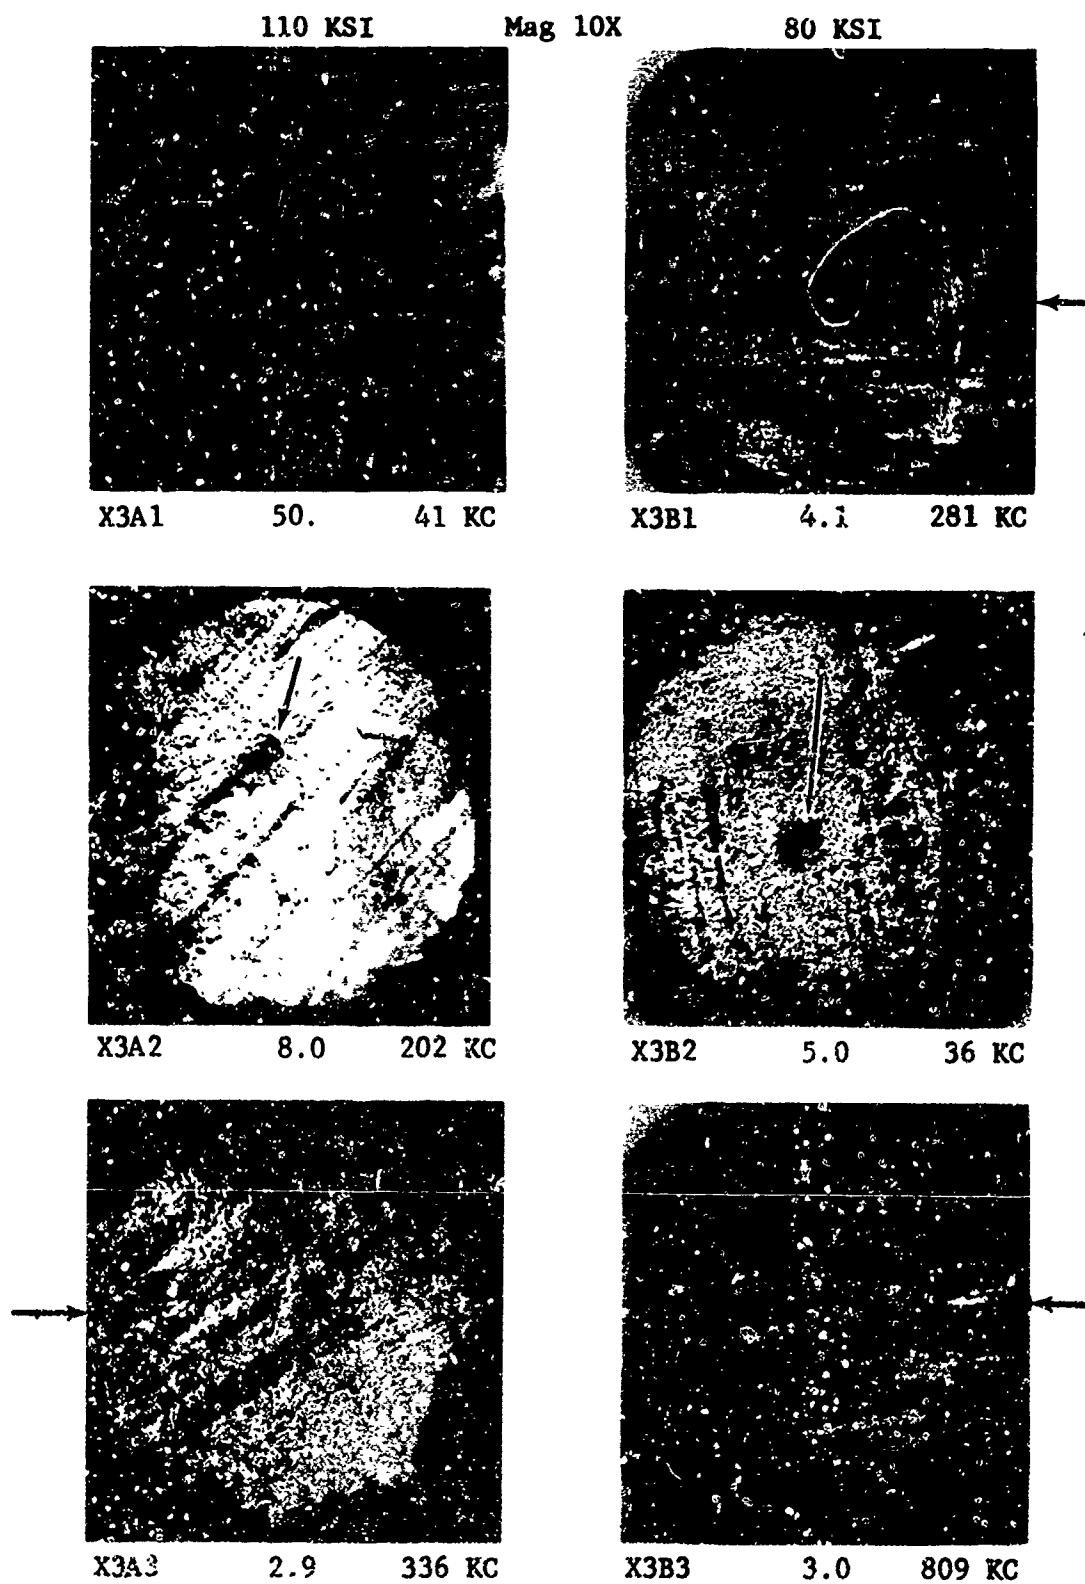
Figure 8.34 Fracture Surfaces of Failed Fatigue Specimens Series X3-  
Single Joint Diffusion Bonded with .013" Dia.  $\text{SiO}_2$   
Powder Inclusion

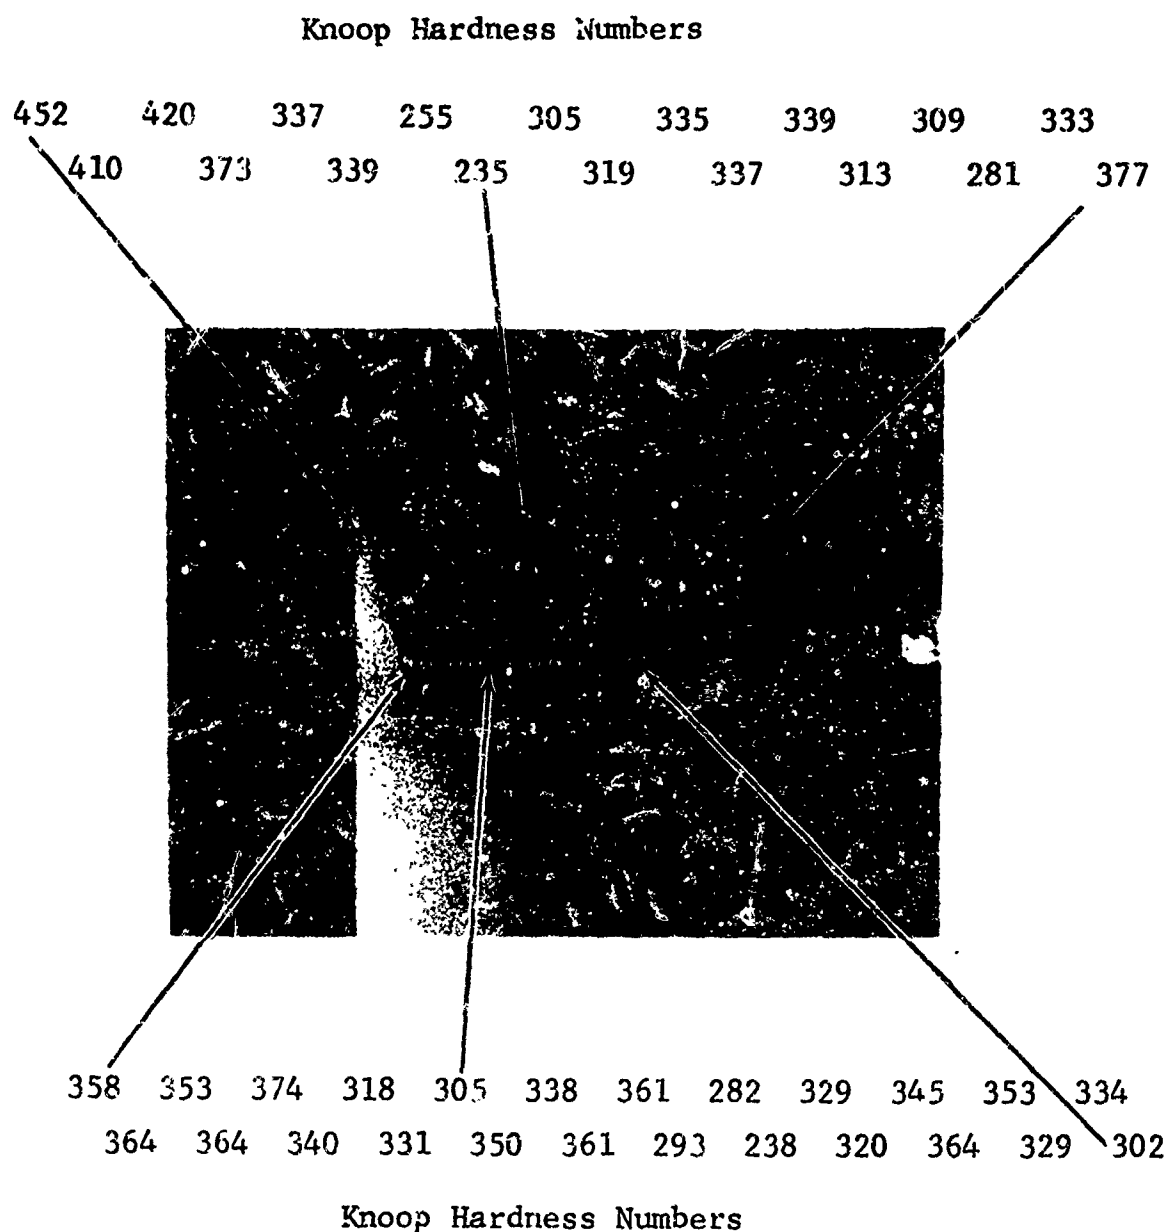
Figure 9.22 Microhardness Variations Across Elliptic Area in Rib Intersection of Part #1.
